**OAK RIDGE
K-25 SITE**

K/SS--546

CYLINDER YARD INSPECTIONS AND CORRECTIVE ACTIONS

Date Published—July 31, 1990

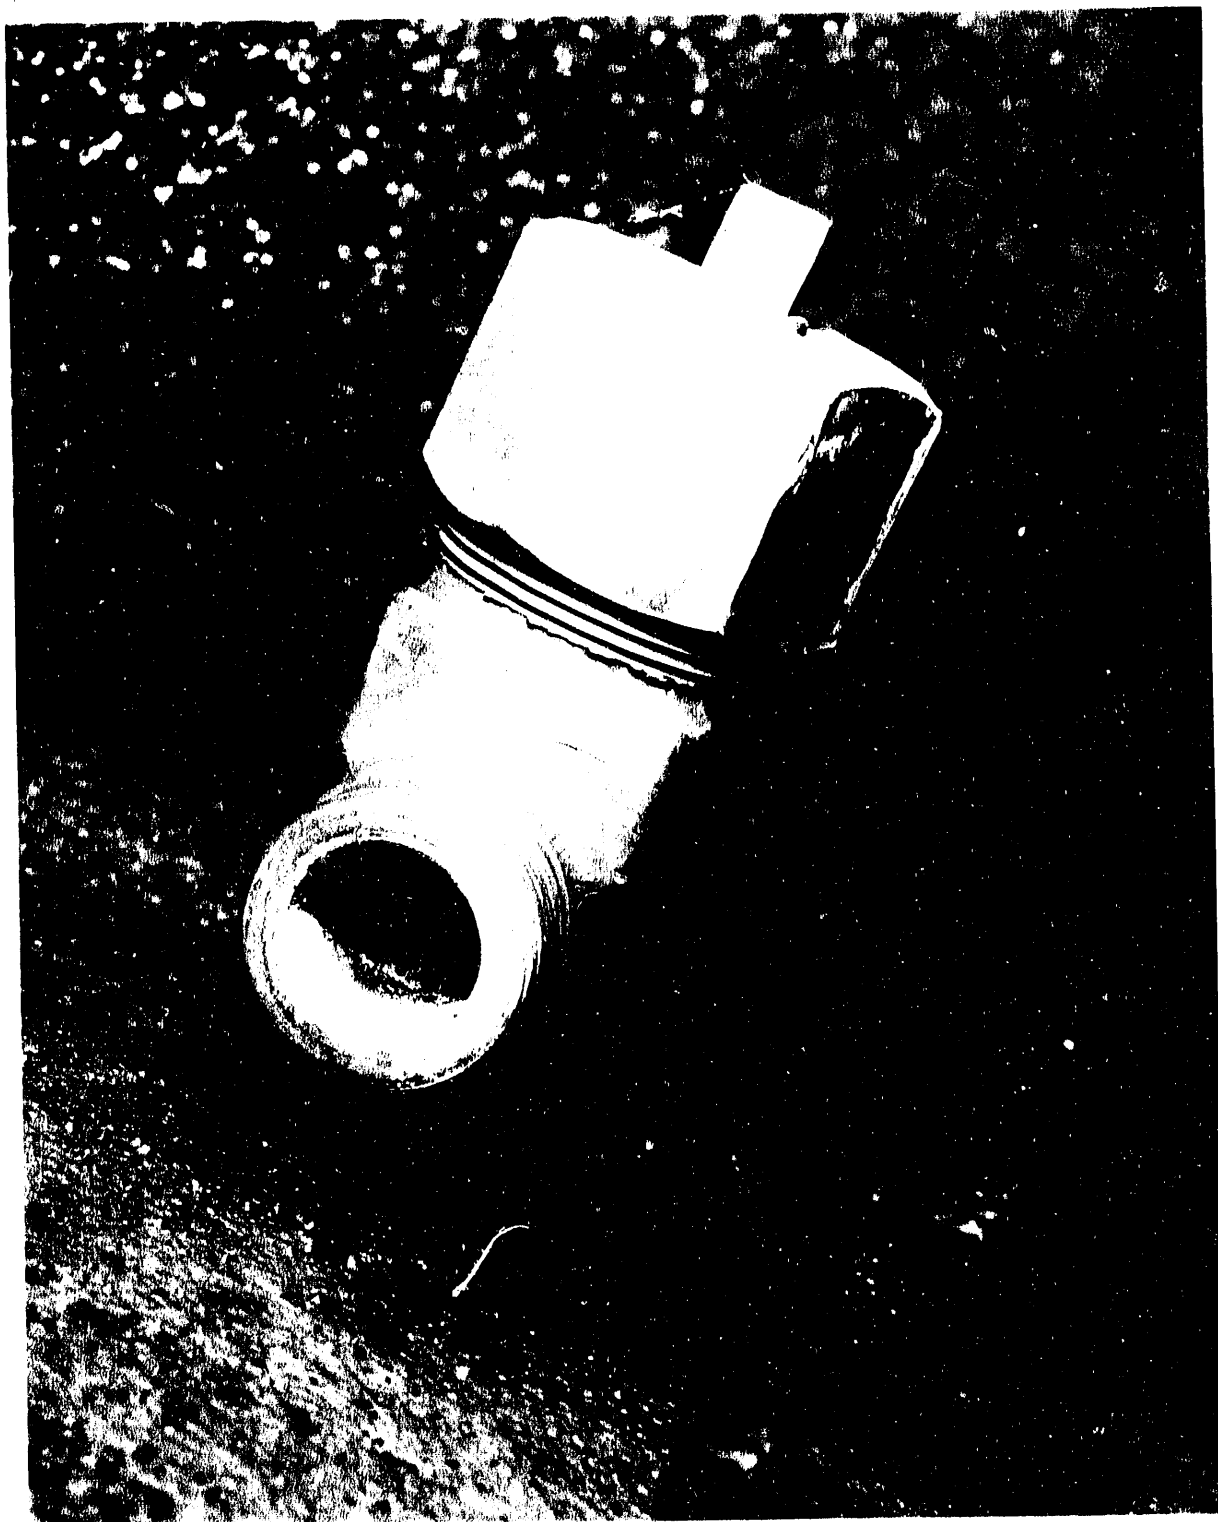
Figure 8

MISSING PORT CAP

Green deposits are evidence of seat leakage
