The Shenandoah Parabolic Dish Solar Collector

George S. Kinoshita

The objectives of the Shenandoah, Georgia, Solar Total Energy System are to design, construct, test, and operate a solar total energy system to obtain experience with large-scale hardware systems for future applications. This report describes the initial design and testing activities conducted to select and develop a collector that would serve the need of such a solar total energy system. The parabolic dish was selected as the collector most likely to maximize energy collection as required by this specific site. The fabrication, testing, and installation of the parabolic dish collector incorporating improvements identified during the development testing phase are described.

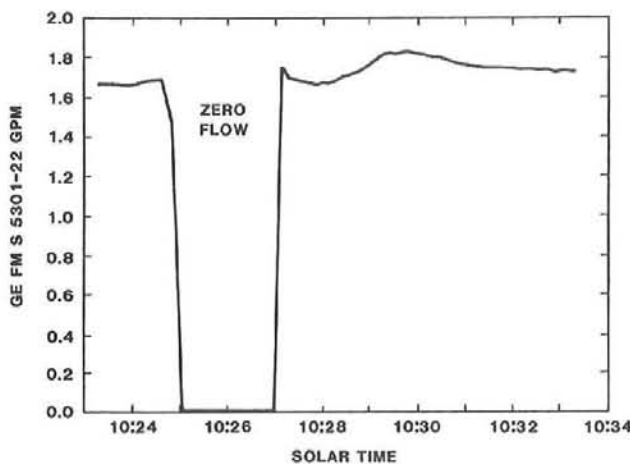
(a) Flow Stoppage

The relative response time of flow stoppage and temperature rise in the detectors is shown in Figures 44(a) and (b). As a result of these tests, the initial idea of using the immersion RTD at the outlet of the receiver coil as the over-temperature indicator was abandoned because of the observed delayed response. The time interval from flow stoppage to a high temperature indication would have allowed sufficient heating of the fluid to exceed the allowable film temperature and cause possible fluid degradation. For Shenandoah, an immersion RTD at the coil receiving maximum flux was implemented to provide the flow-stoppage over-temperature indication.

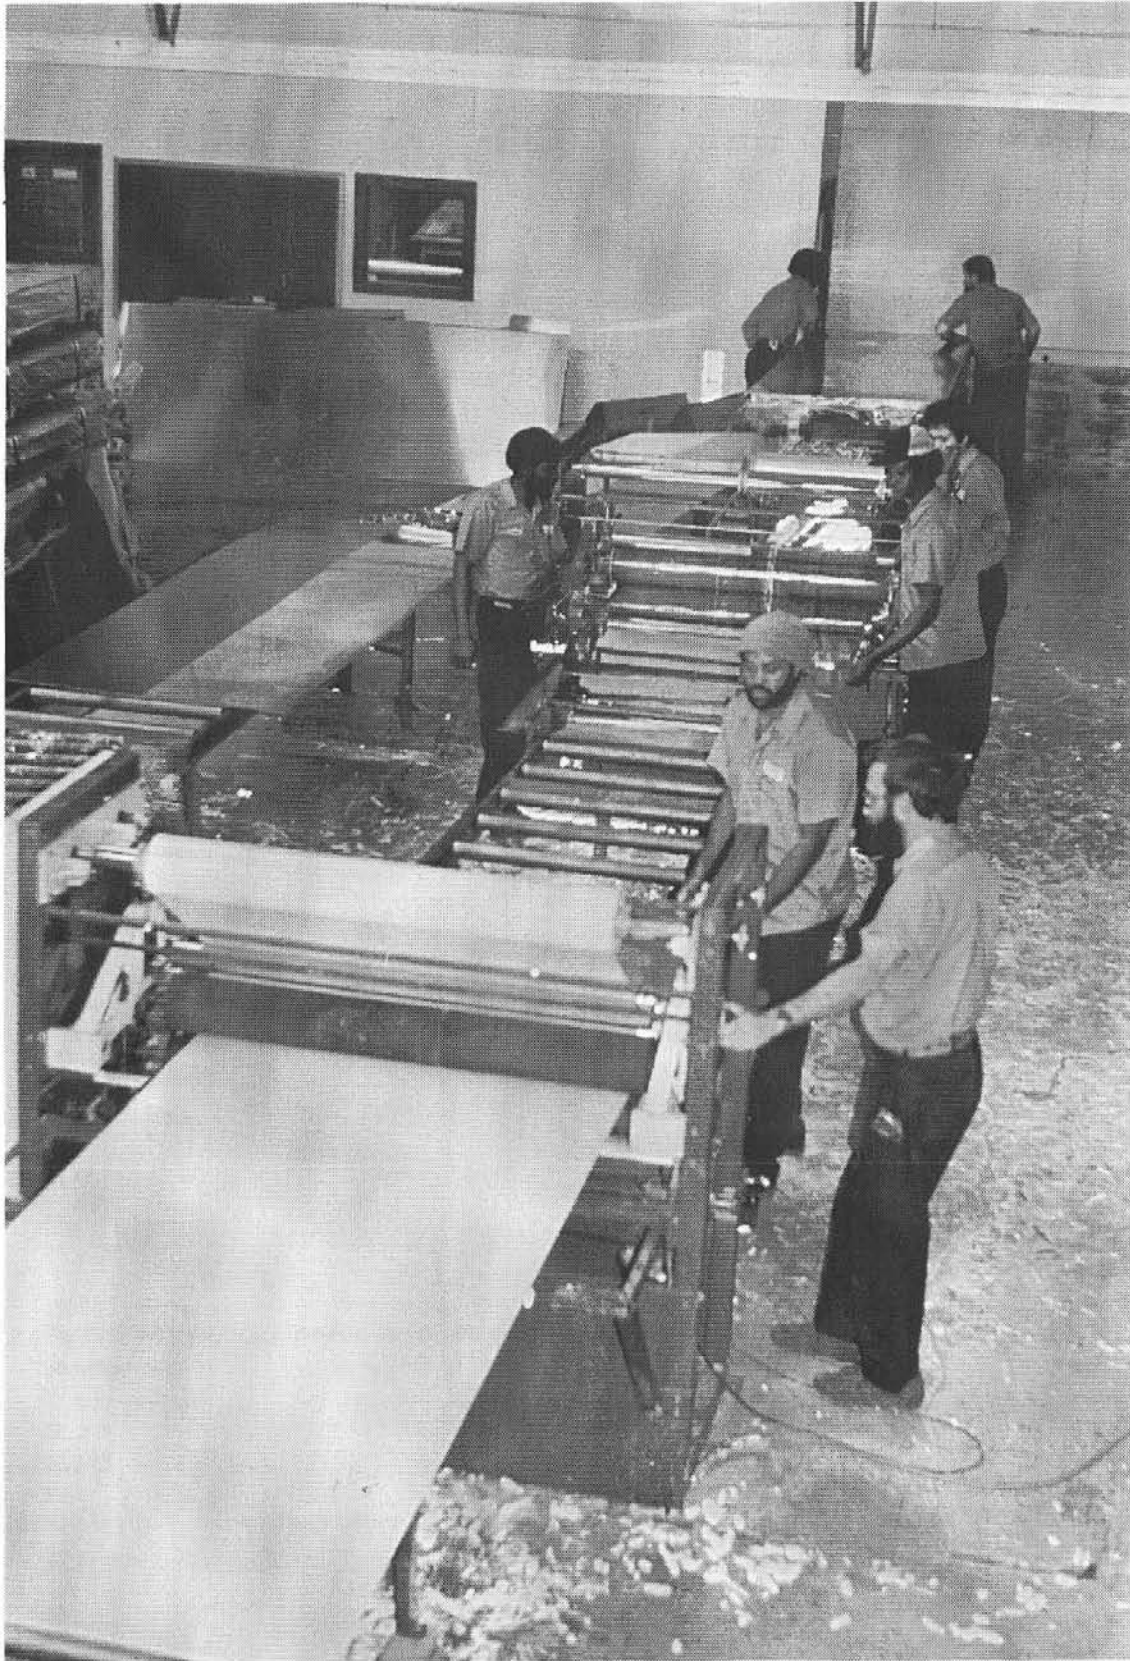
Figure 48. Reflector Laminating Process

To expedite production of the GE-designed collector for the Shenandoah STEP, procurement of the aluminum and the FEK-244 film for the reflector was made under government funding. Lamination of the two materials was also performed under government contract (Figure 48). 2600 FEK laminated aluminum sheets covered with a white premask protective film was provided as GFE to the collector contractor. Loan of the die and gauges for fabricating and checking the reflector petal sections was also made to the contractor.

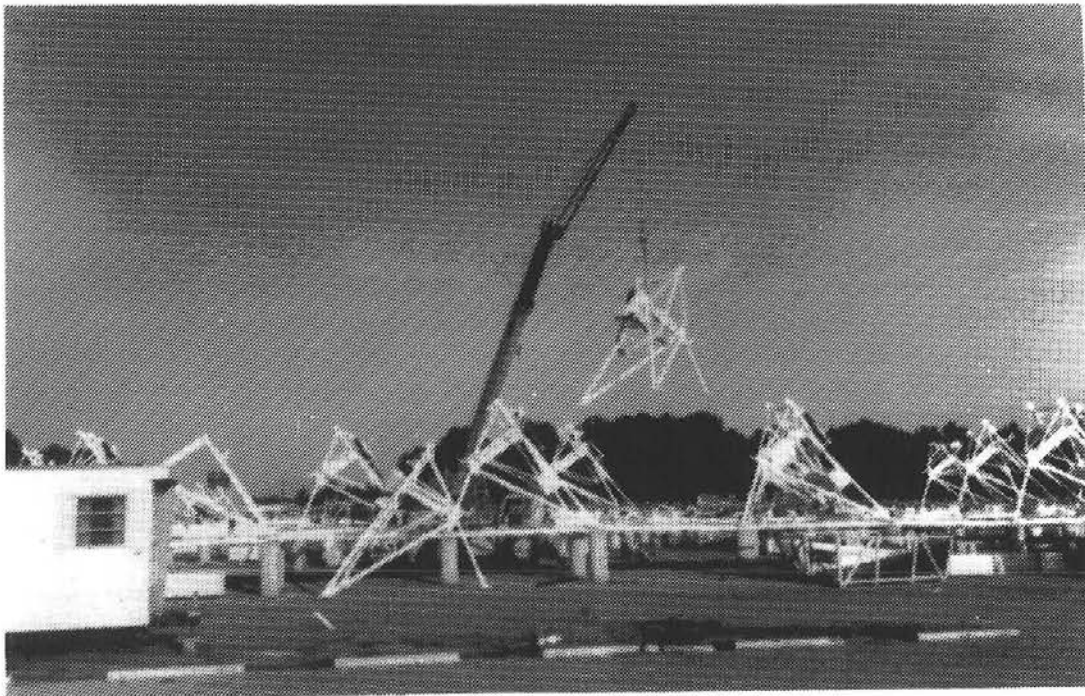
FIGURE 1

Temporarily tie cable to northeast leg of frame so counterweight will clear. Also, tie declination motor cable so leads will not short on frame and frame can rotate about polar axis. Cable will be installed permanently at final assembly with RTD cable and fiber optics.

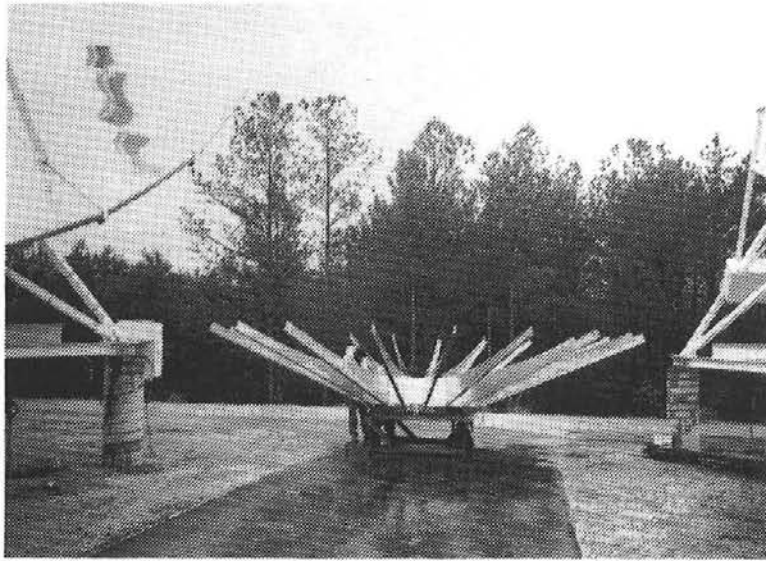
FIGURE 3

Now, install the rest of the hardware, but do not tighten at this time. Start on the inside row and tighten all 21 screws. Then, tighten the next row. Work all the way around before starting next row. Continue until all screws are tight on all panels. Then, tighten the 3/8 screws through the ribs to hub.

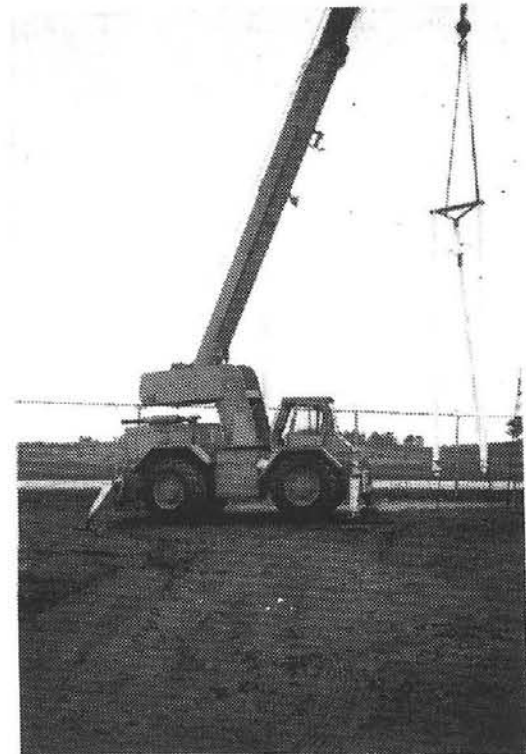
FIGURE 6

2. Use 3, 12 ft. long x 2½" wide chokers. Wrap one around the center of each leg of the triangle. Hook other end in hook of crane. Lift struts to vertical position. Tie the tag line to each strut for guiding into position over reflector. (See Fig. 6)

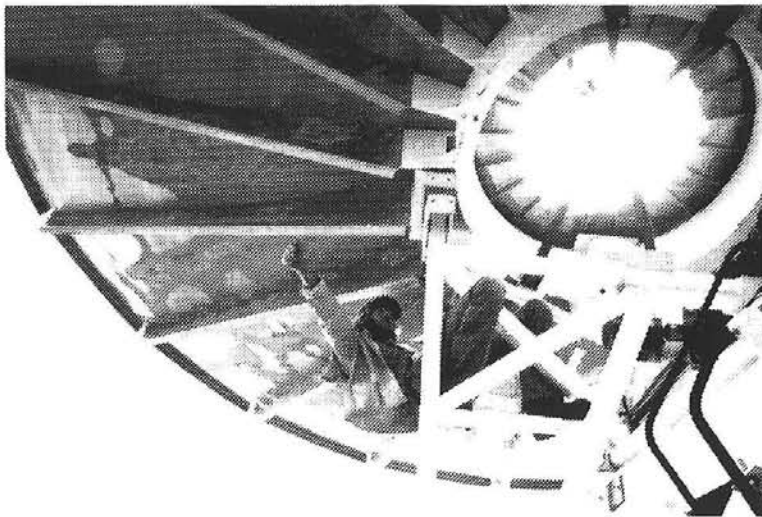
FIGURE 8

3. With 2 men tending the 2 tag lines left on the struts, pick up the reflector assembly with the crane, using the tag lines to steady the reflector and help guide it. Position reflector over frame assembly and lower bearing housings in hub onto bearing blocks. (See Fig. 8) Have at least one man up on frame to help guide reflector into place. Use line-up bar to align bolt holes. Using the slope washer under bolt head, put bolts in from topside. Put the slope washer on top of channel so that bolt will be 90° to bearing block. With all four bolts in one bearing block, install on bottomside one flat washer and one lock nut. Torque bolts to 35 ft. lbs. minimum. Repeat bolting procedure on other side. Please note: On the westside bearing block, install a grounding strap from hub to frame.

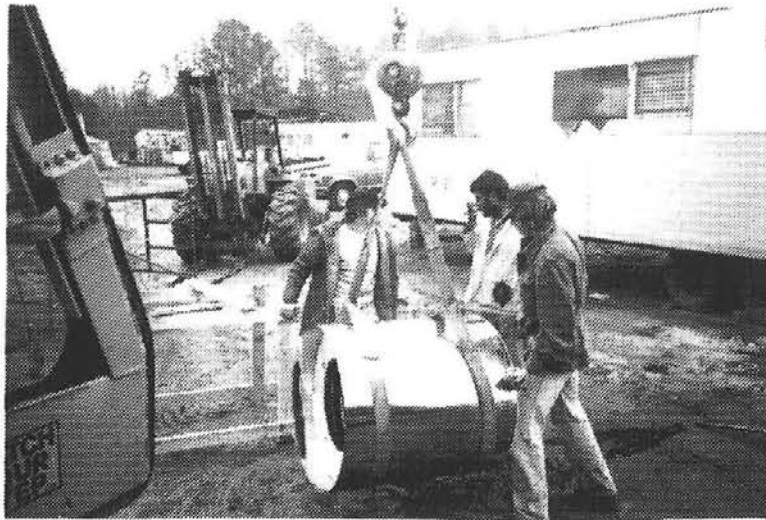
FIGURE 9

5. Move receiver into position and insert bolts through strut and receiver mounting support with 2 flat washers, 1 on either side, 1 lock washer and 1 hex nut. Do not tighten at this time. Adjust leveling pads to approximately same length to center receiver between struts. Now, extend leveling pads until a very slight bow is noticeable in each strut. When each strut has the same amount of bow, lock leveling pad with jam nut, then, tighten bolts through receiver mounting supports.

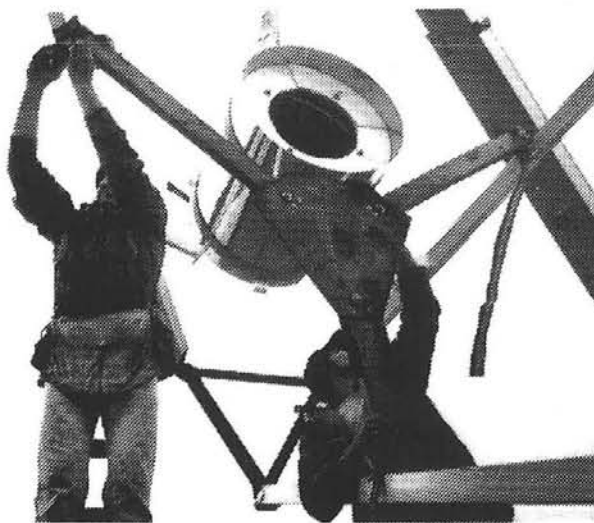
FIGURE 10

4. Put strut spreader fixture between struts and remove triangle from front of struts, as shown in Fig. 10. Extend the leveling pad on south strut to approximately 3" and retract the other two leveling pads.
